Text and photos by Jens O. Meissner and Helmut Spangler

# Lake Zurich

— *Deep Cold-Water Wreck Diving in Switzerland*

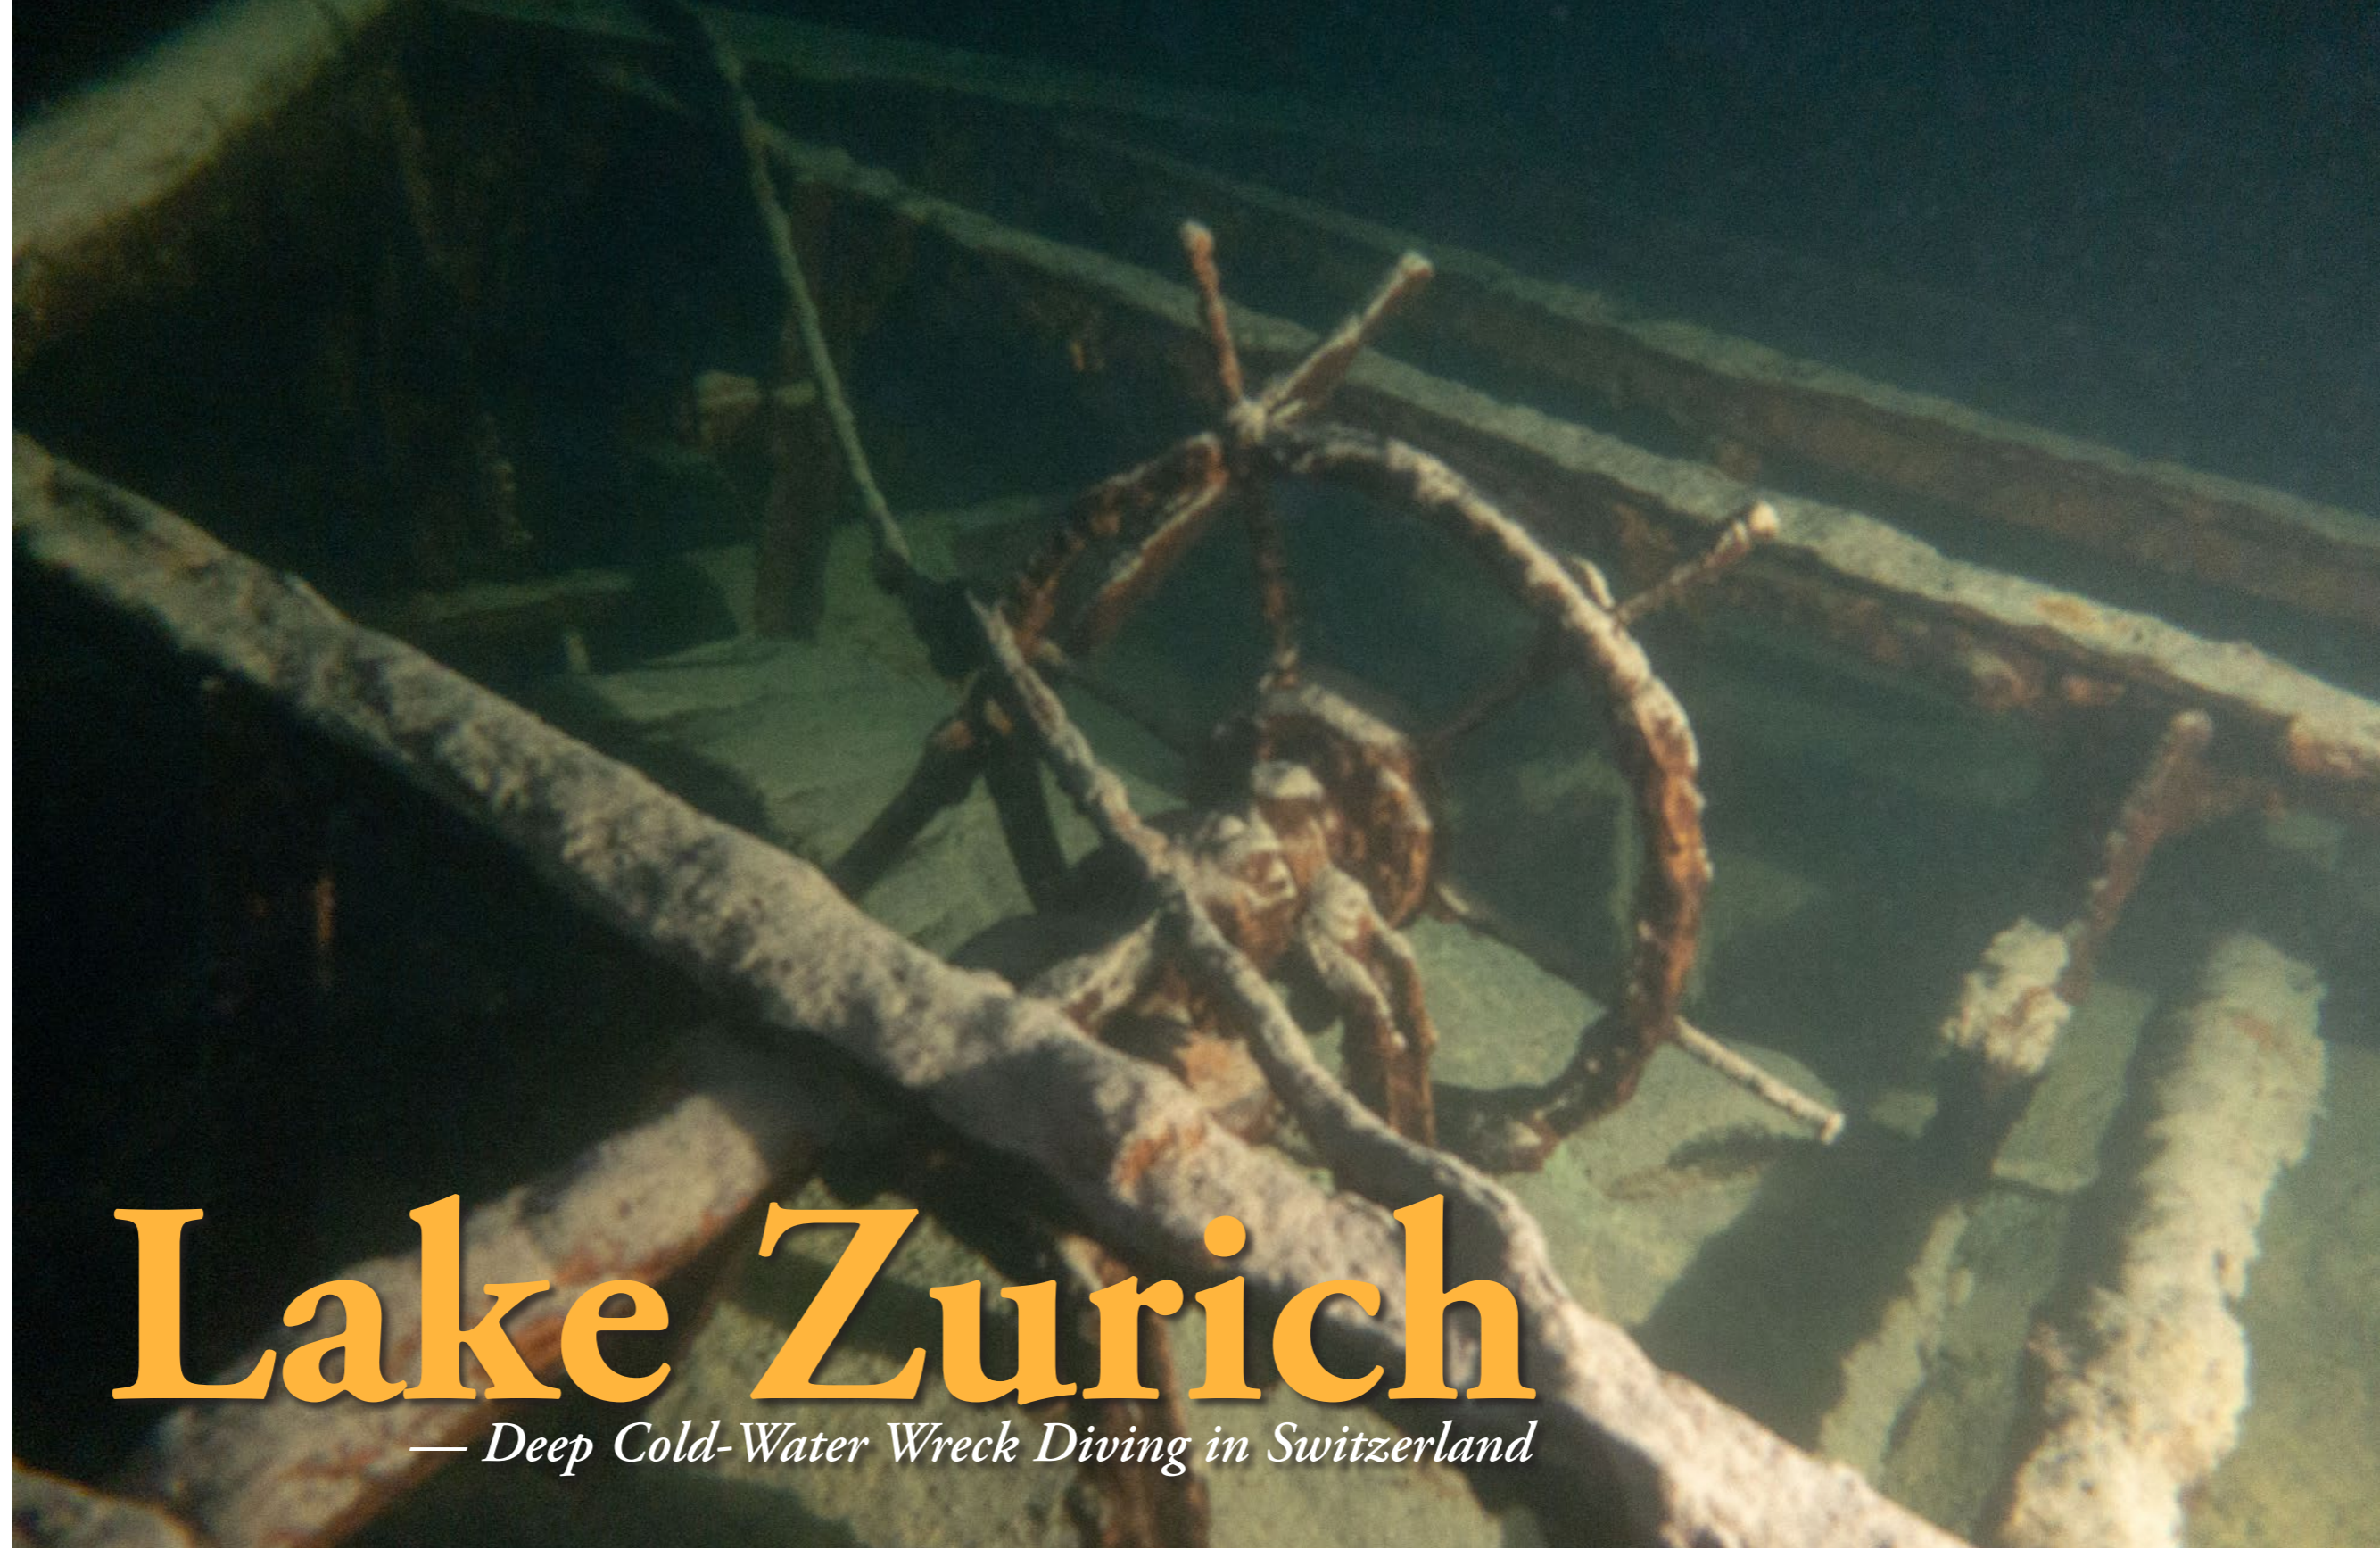
Ship's wheel on recently discovered wreck of a motorized cargo ship thought to date from the late 19th or early 20th century

Ship's wheel (left), starboard side (above), and motor block (right) on the second wreck found—a late 19th or early 20th century motorized cargo ship

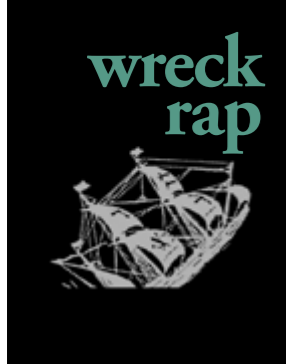
Clearly recognizable composite construction on the wreck of a 19th century cargo ship with cabin, recently discovered in Lake Zurich

height. It has a cabin at the stern and a cargo area, which spans over the first two-thirds of it, with a beam pump in the middle. The ship has noticeable steering gear, with a rudder blade and winch behind the cabin. The winch could pull up the rudder to allow disembarking on the shallow banks of the lake. This type of steering gear was a special construction specific to this region and has only been found once before in Switzerland. The rudder blade has a typical curved form.

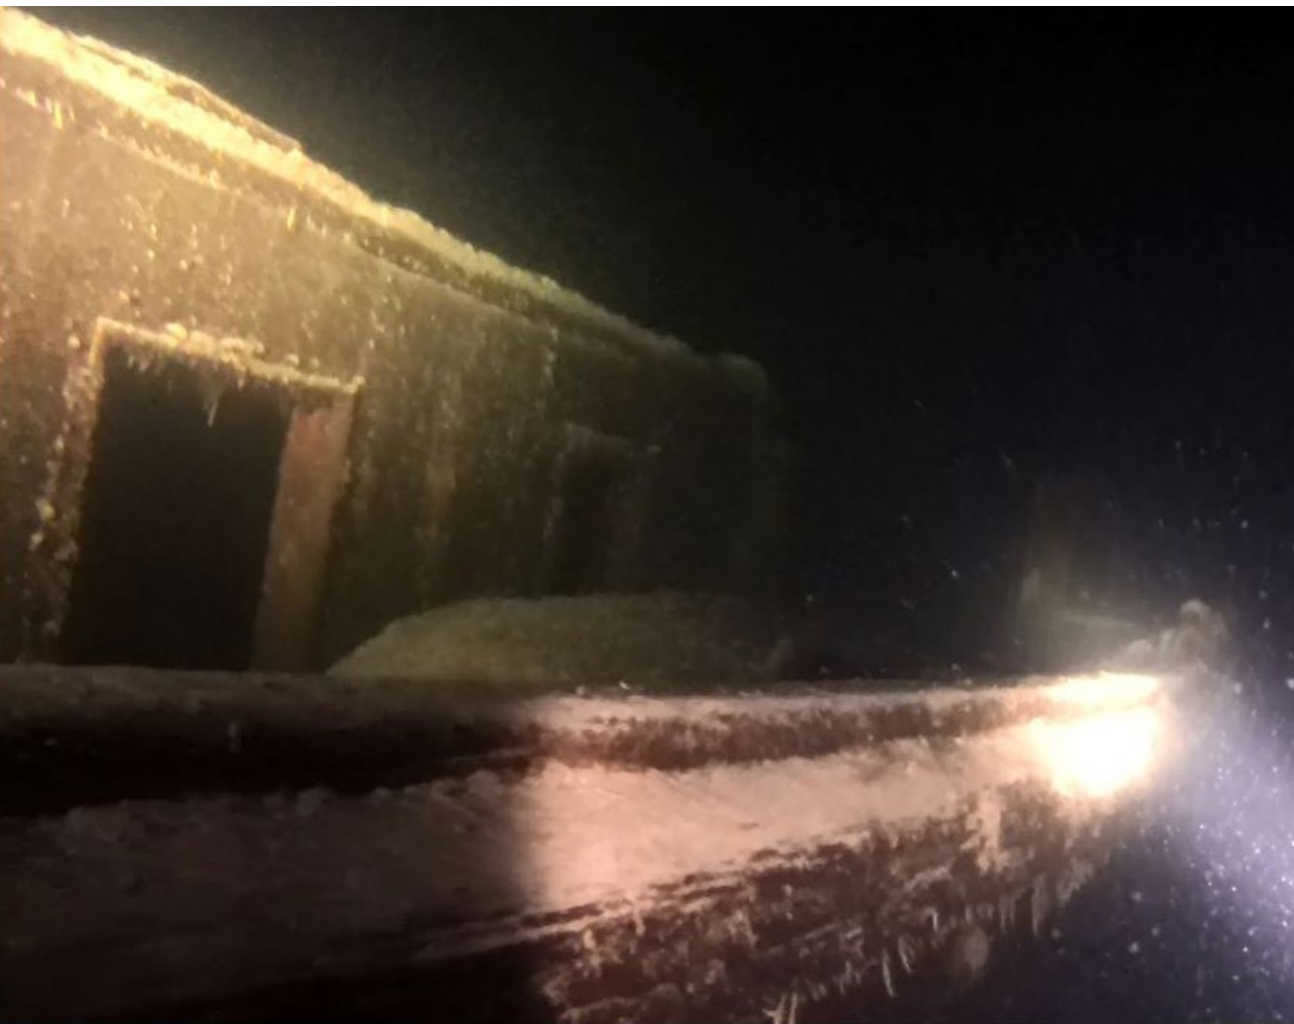
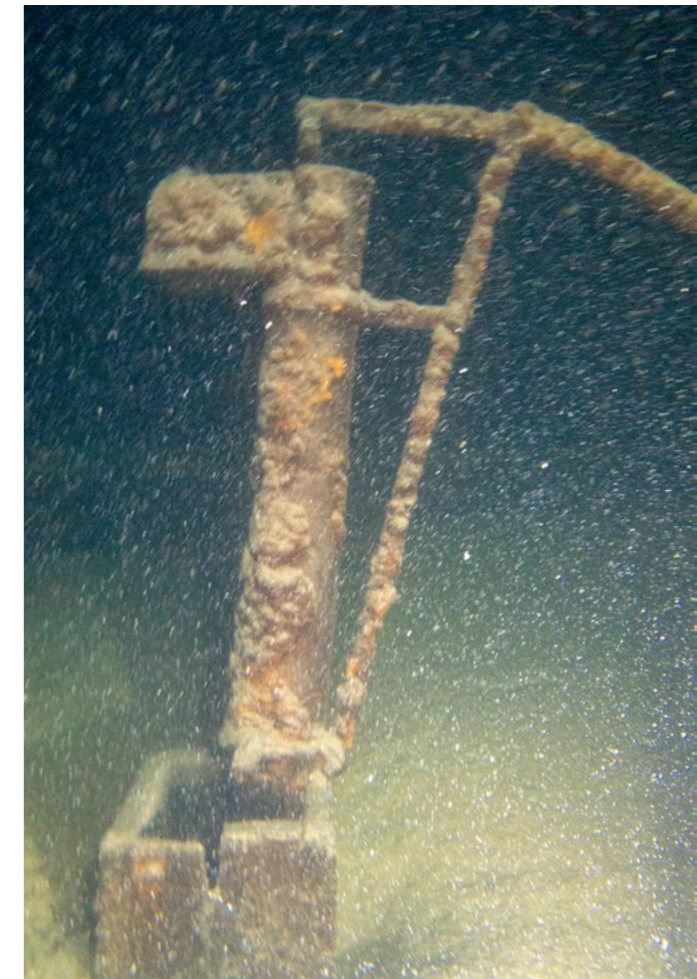
A hand pump used to remove bilge water (above); Diagram of the first wreck site (left)

Starboard side of the first wreck—a 19th century cargo ship—recently found in Lake Zurich

The shipwreck measures 22m in length, six meters in width and approximately three meters in

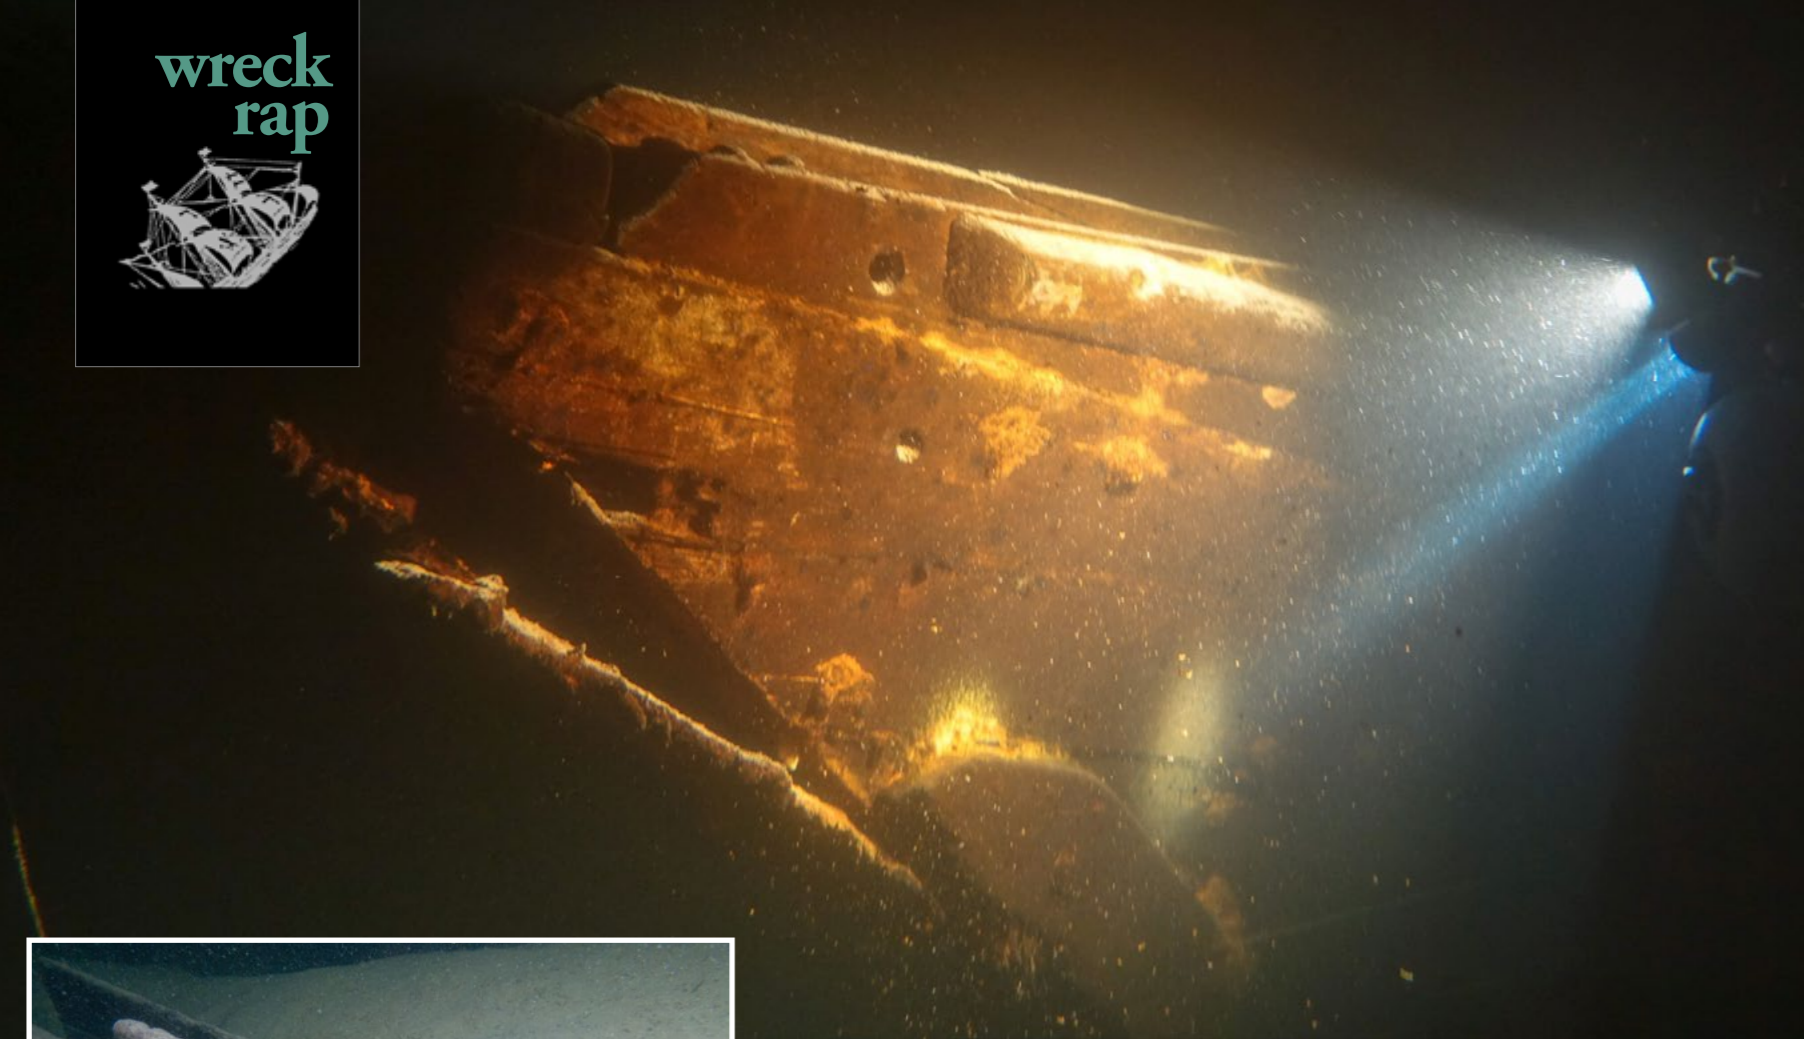
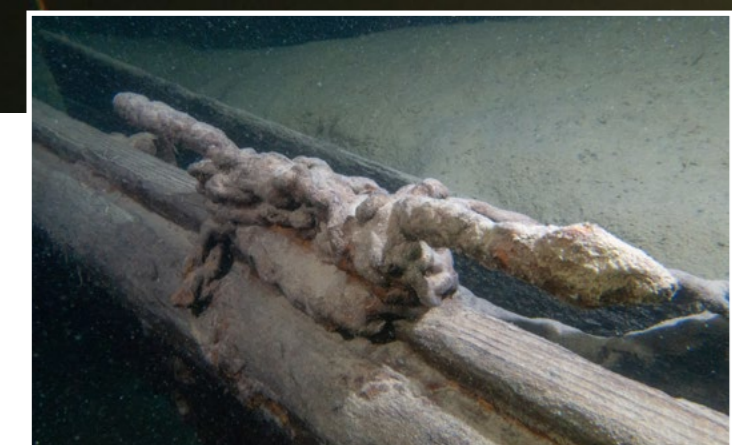
Historical photo of a cargo ship (above), similar to the motorized cargo ship found (right)

Horn cleat (left) and bow (above) on the first wreck site found—a cargo ship

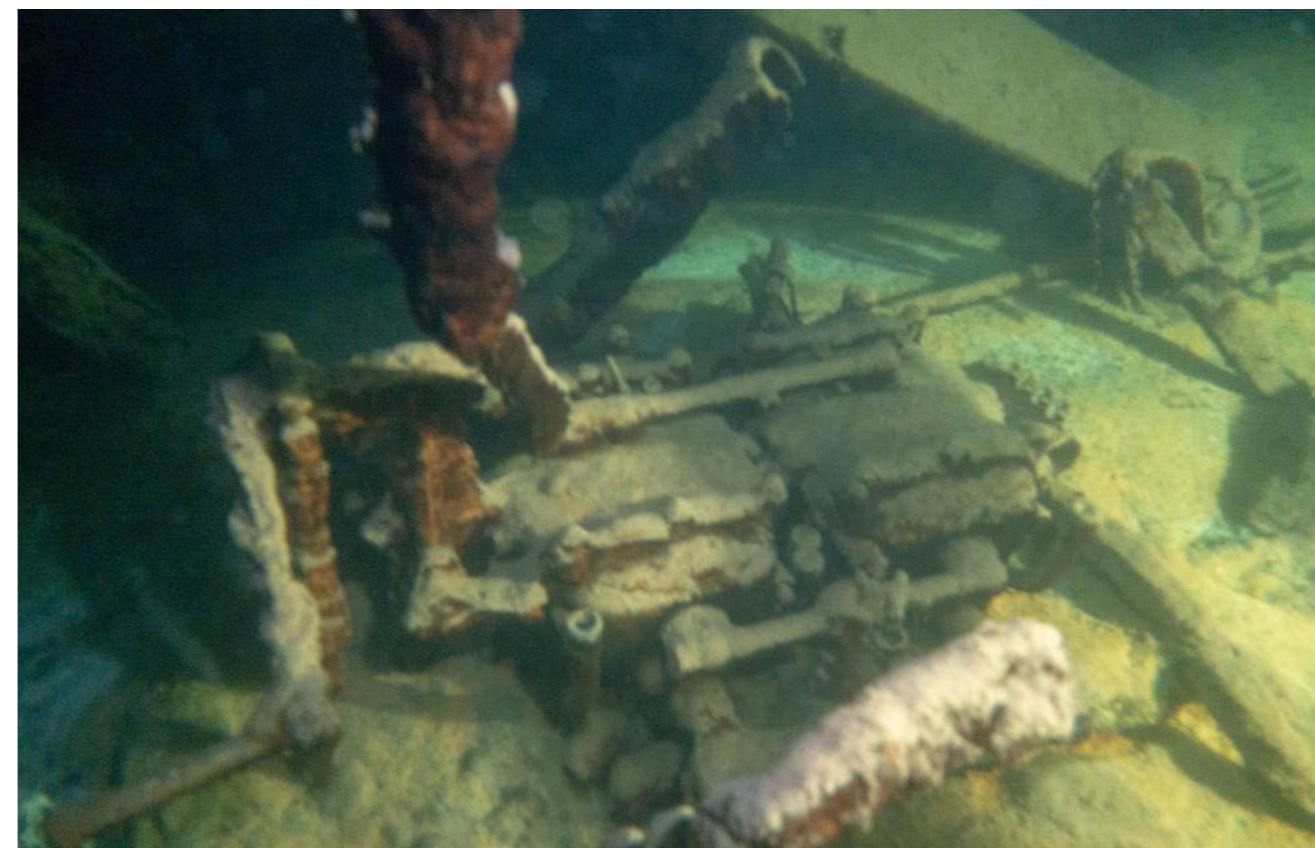
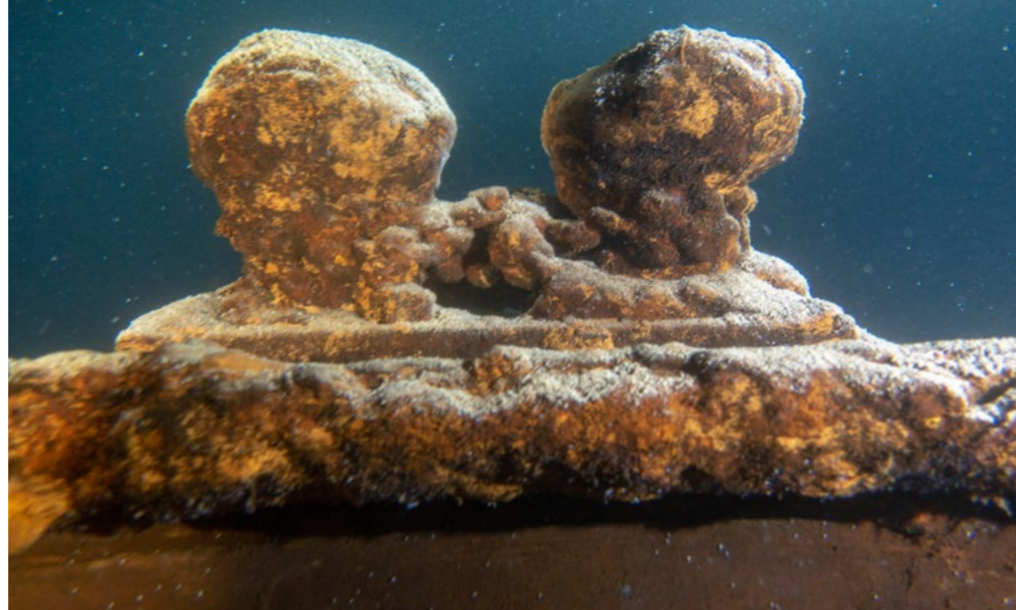
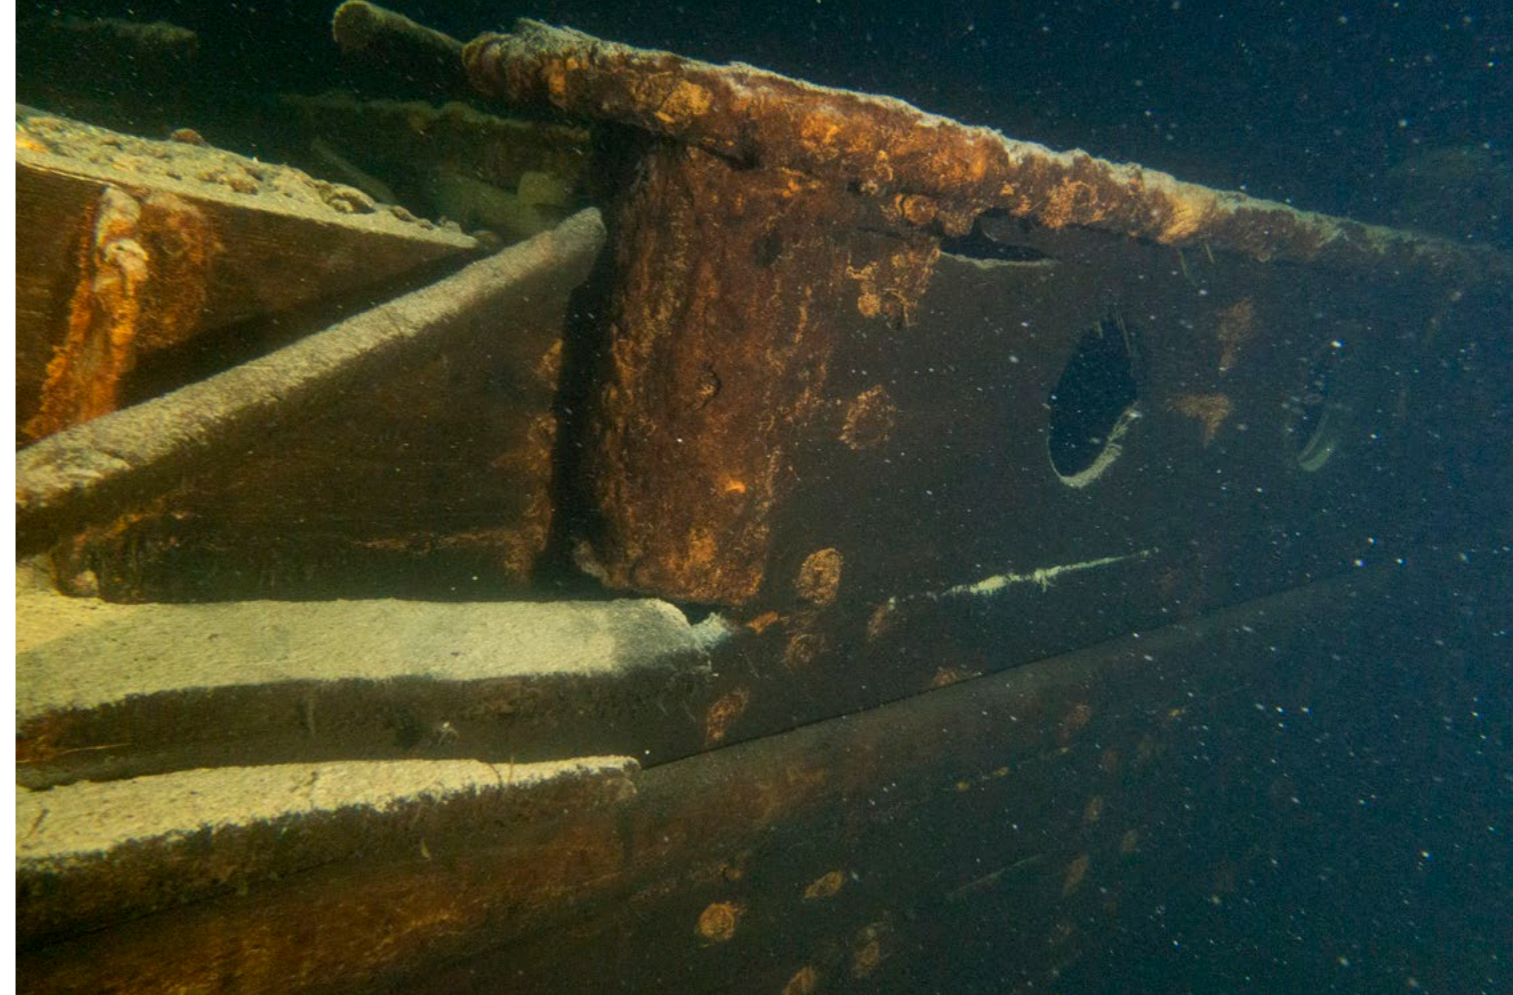
Cleat (right), deck cabin (far right), and covered portfhole (below) on the recently discovered wreck of a motorized cargo ship in Lake Zurich, estimated to date from the late 19th or early 20th century

has been discovered in Lake Zurich so far. Again, the cabin covered a fourth of the length at the stern, whereas the rest comprised a cargo hold with three different segments. The unroofed cabin gave us a view and insight into the vessel's interior life. It still had covered portholes in place. The middle of the cabin hosted a two-cylinder engine, which also drove the bilge pump. Additionally, it drove a hydraulic system that could open the bottom of the cargo hold in order to dump the cargo into the lake (whatever it was). The steering gear and the helm sat in place, but the rudder blade had been lost during the descent. The hull had a double wall and the space between was used for hydraulic pipes and storage of the rudders. The hull was

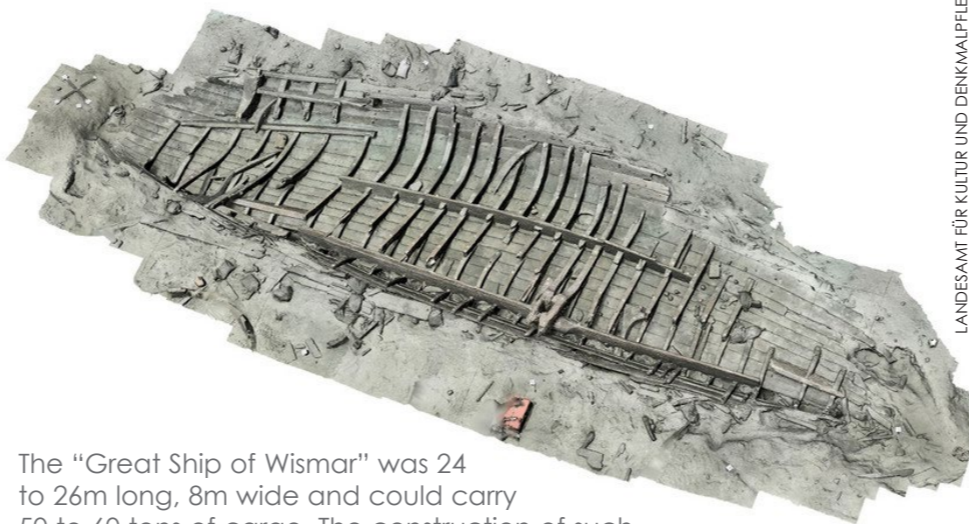
The "Great Ship of Wismar" was 24 to 26m long, 8m wide and could carry 50 to 60 tons of cargo. The construction of such large, sea-going merchant ships required vast resources and are indicative of a professionalised maritime trade in bulk commodities. The owners would have been rich merchants, members of the nobility or the clergy.

Maritime archaeologist Dr Jens Auer, who led the project, described the ship as a descendant of Viking vessels and said, "It was a heavy, load-bearing cargo ship." It had overlapping pine planks, clinker-style, with "beautiful curved construction" and was made during a relatively peaceful period of the time. It is estimated that the ship had a crew of 8 to 12 men.
